# Vibration Analysis of Hydro Mechanical Structure Upper Kotmale Hydropower Plant

T. Namba

**Keywords:** Hydroelectric, Penstock, Vibration, Resonance, FEM

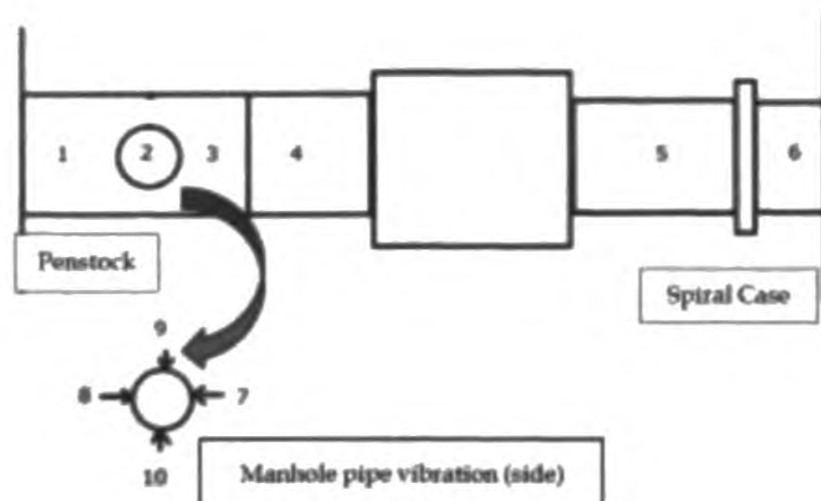
Figure 1 - Vibration measurement position by using handy vibration meter

Position	1	2	3	4	5	6	7	8
Apr.15 2012 (Before countermeasure)	48.7	22.0	32.0	16.4	7.4	5.6	32.2	31.2

Considering the high vibration level in the penstock area, resonance of the penstock structure with the excitation frequency generated by the turbine operation could be a cause of the vibration. The excitation frequency generated by turbine operation is as follows.

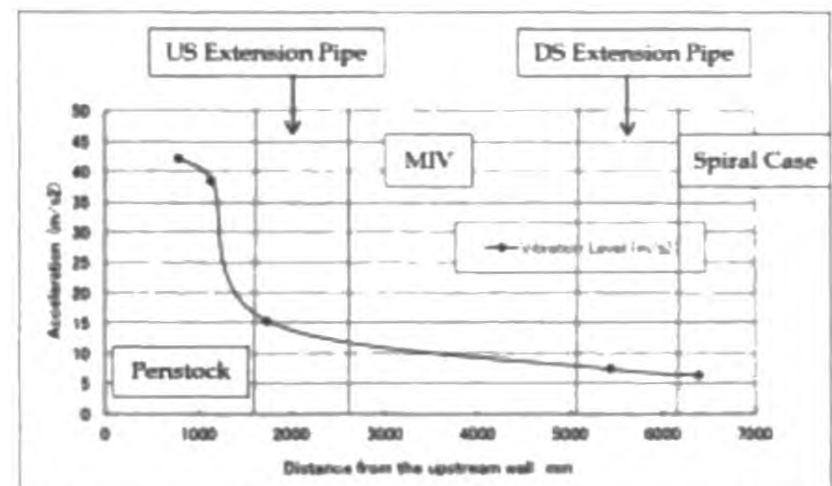
Figure 2 - flow directional vibration variation

By using the measurement result of position 1 to 6 shown in Table 1, flow directional vibration variation is drawn as Fig.2. -

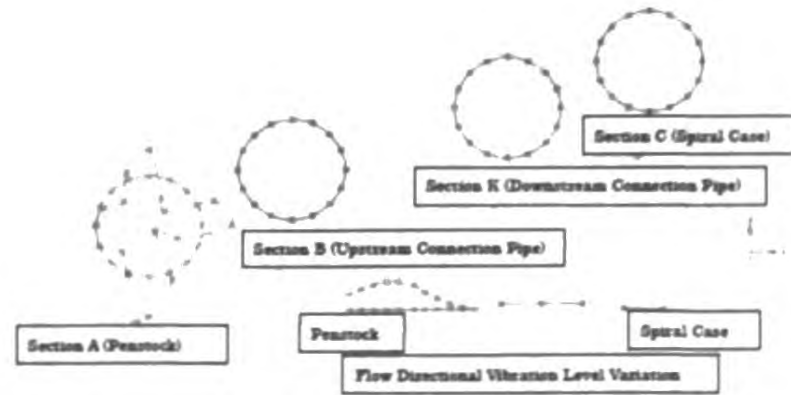
Figure 4 - Vibration mode at 181.5Hz

- Penstock section has a natural frequency of 181.5Hz. That is close to the excitation frequency of 180Hz.
- Vibration mode of the penstock section at the frequency of 181.25Hz is 4ND shape.
- Vibration response level of penstock section is significantly higher compared to extension piece sections and spiral case sections.

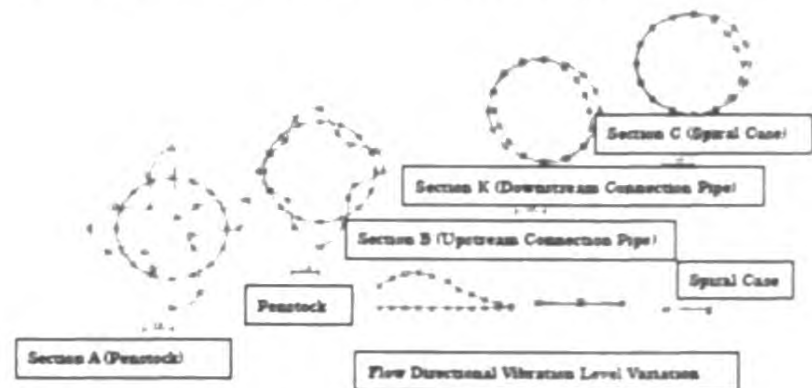
Figure 5 - Vibration mode shape during unit operation ( $nZr=180\text{Hz}$  component)

- Penstock vibration level measured at the highest position is about  $\pm 35\mu\text{m}$  in vibration displacement.
- Penstock is vibrating in its natural frequency in the 4ND vibration mode as measured during the tapping test.
- Vibration response level in the penstock section is significantly higher than that of extension piece and spiral case.
- Vibration level is governed by  $nZr$  Component and the vibration response level against  $nZr$  excitation force governs the vibration level as shown in Fig.6..

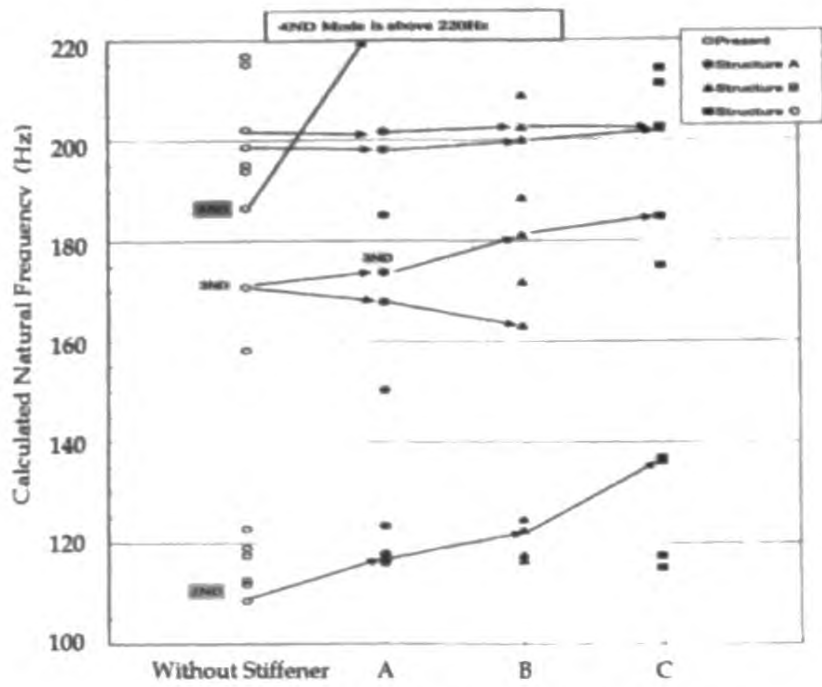
Figure 10 - Calculation Result of Natural Frequency

Mechanical structures have various natural frequencies. Fig.10 shows the natural frequency calculation result. 4ND natural frequency vibration mode, which is close to the excitation frequency and considered to be in resonance, can be increased by providing ribs, but 3ND vibration mode, which resides below the excitation force frequency, also increases and comes up to around excitation force frequency of 180Hz. To mitigate the vibration level, stiffener shall be designed so that the natural frequency of the structure that has high response level and may result in resonance can secure enough avoidance ratios against the excitation force frequency.

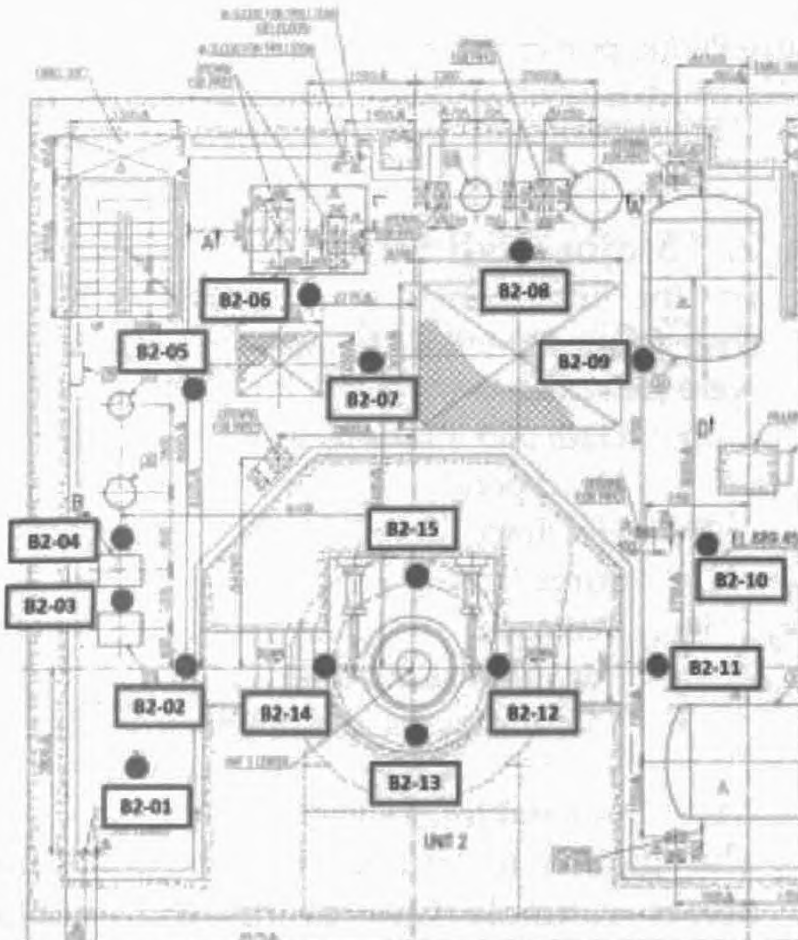
Figure 14 - Vibration measurement position on B2 floor

B2-01	B2-02	B2-03	B2-04	B2-05	B2-06
Apr.17 2012 (Before countermeasure)	7.4	7.2	3.9	3.3	1.0	3.1
Apr.6 2013 (After countermeasure)	3.3	4.3	2.2	1.7	2.6	1.1

B2-07	B2-08	B2-09	B2-10
Apr.17 2012 (Before countermeasure)	-	2.7	-	4.1
Apr.6 2013 (After countermeasure)	1.1	0.7	2.4	0.7

As the vibration on the penstock reduced, vibration level on the floor also reduced accordingly.

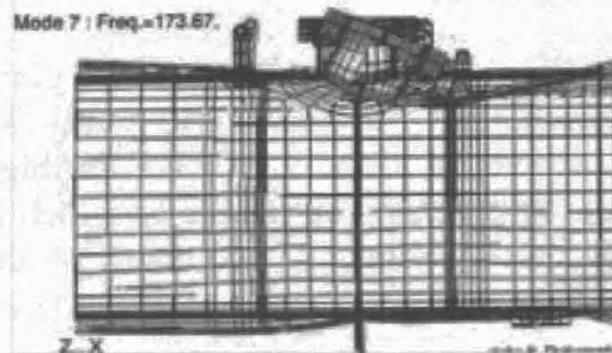
Figure-15 Vibration Mode that Resides around 180Hz after providing stiffener. (FEM result)

Based on the measurement result, vibration level on equipment has significantly reduced after the countermeasure where the vibration level had been originally high. Manhole side vibration remains high even after the countermeasure. This is considered to be

affected by the vibration mode of the structure that resides around 180Hz for which enough resonance avoidance could not be given by providing the stiffener.

- Vibration level of the penstock have reduced to the amount of approx. 50% after the implementation of the countermeasure except for the vibration level at the side of the penstock manhole pipe.
- Penstock manhole pipe vibration level remains unchanged. This is thought to be due to the vibration mode that resides around 180Hz in which vibration level around the penstock manhole is large.
