ORIGIN AND FINAL CUT-OFF OF THE WANASGALLA WATTA MEANDER OF THE DIKOYA, CENTRAL SRI LANKA

ABSTRACT

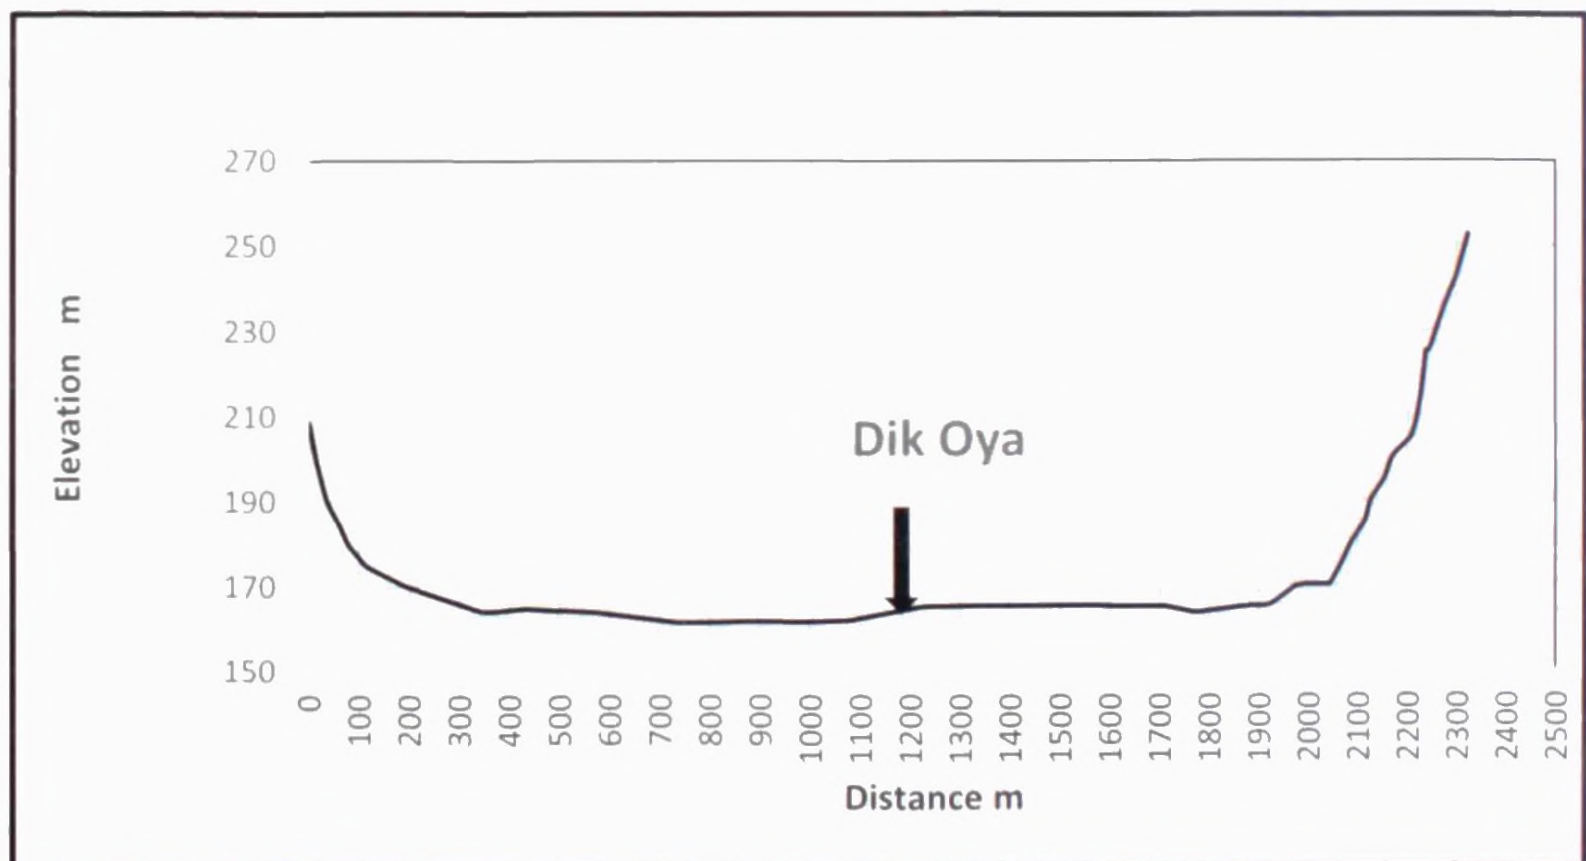
Fig. 6 Aggradation of the Dik Oya Valley.

- The 165 m contour shows a wedge shaped body of sediment and does not show the presence of a valley where the main channel of Dik Oya is located. The contour bends in a down-valley direction (Figure 5 and 6). The position of the the Dik Oya main channel in the broad flat valley is not at the lowest position. The valley surface tends to slope

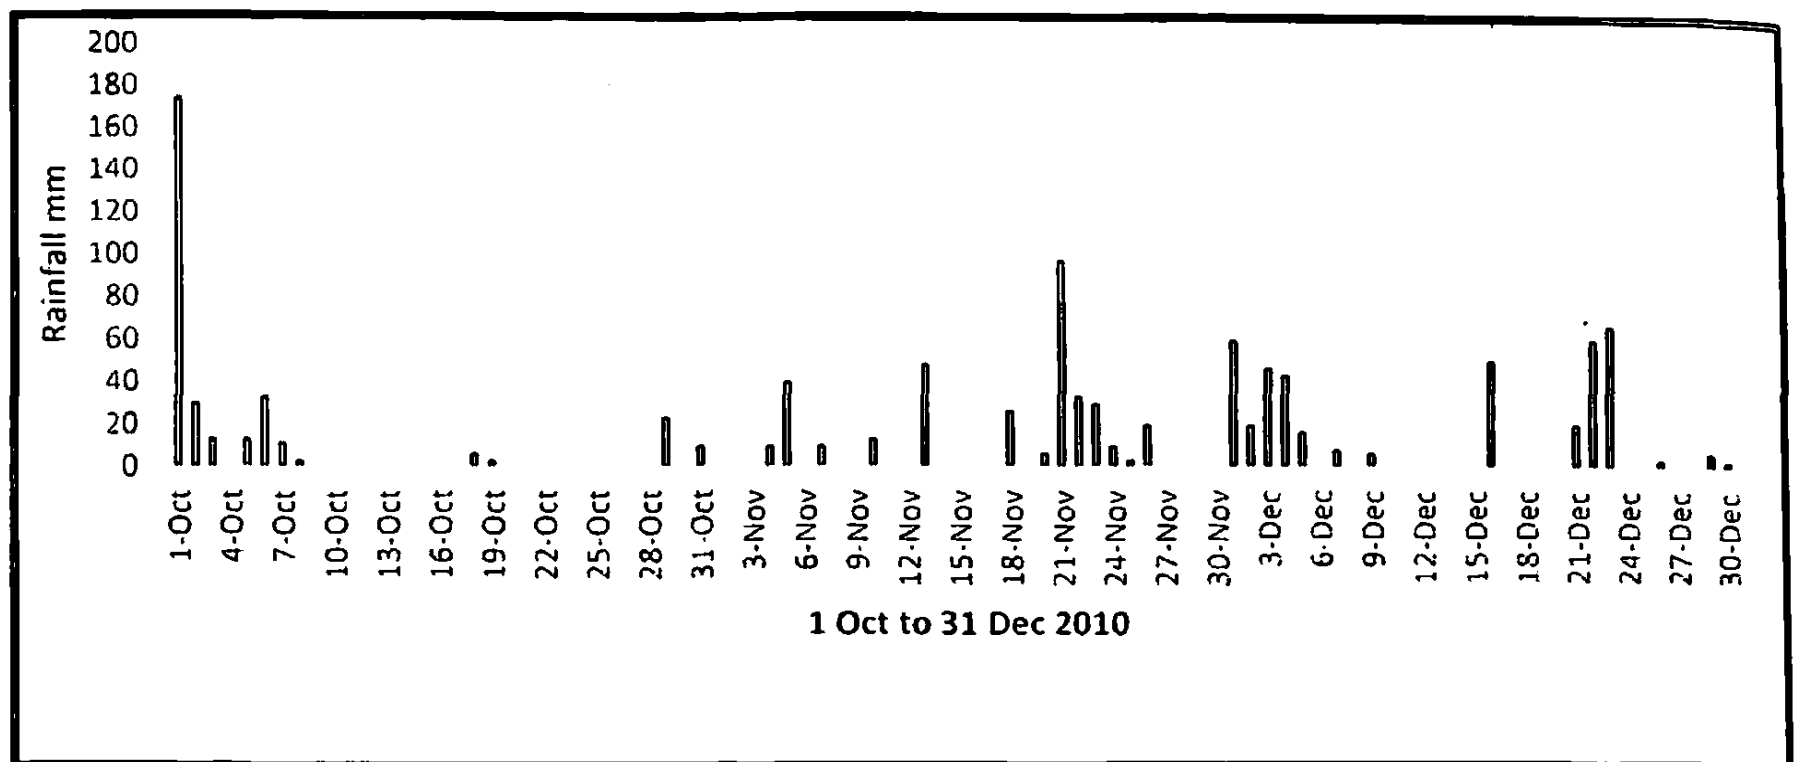
Fig. 8 Rainfall before the Meander Cutoff on.

stabilized by the government authorities to protect the road, that prevented further narrowing of the meander neck at point B (Figure 4). Another spell of heavy rains in October and November, 2010 caused erosion of the LB just below the Malliyagoda Bridge. On October 1st, 2010, 174 mm of rain fell in 24 hours. This was the most destructive event which brought fallen trees from the upper catchment and partially blocked the channel at C (Figure 4). The rains continued till October 9th with a reduced intensity (Figure 8). Another spell of heavy rains started on 28th October peaking on 21st November. Blocking of the channel by trees forced the flood water to create a new channel connecting the upper and lower channel segments of the meander on this day (Appendix Plate 1 and 2). Thereafter, the new

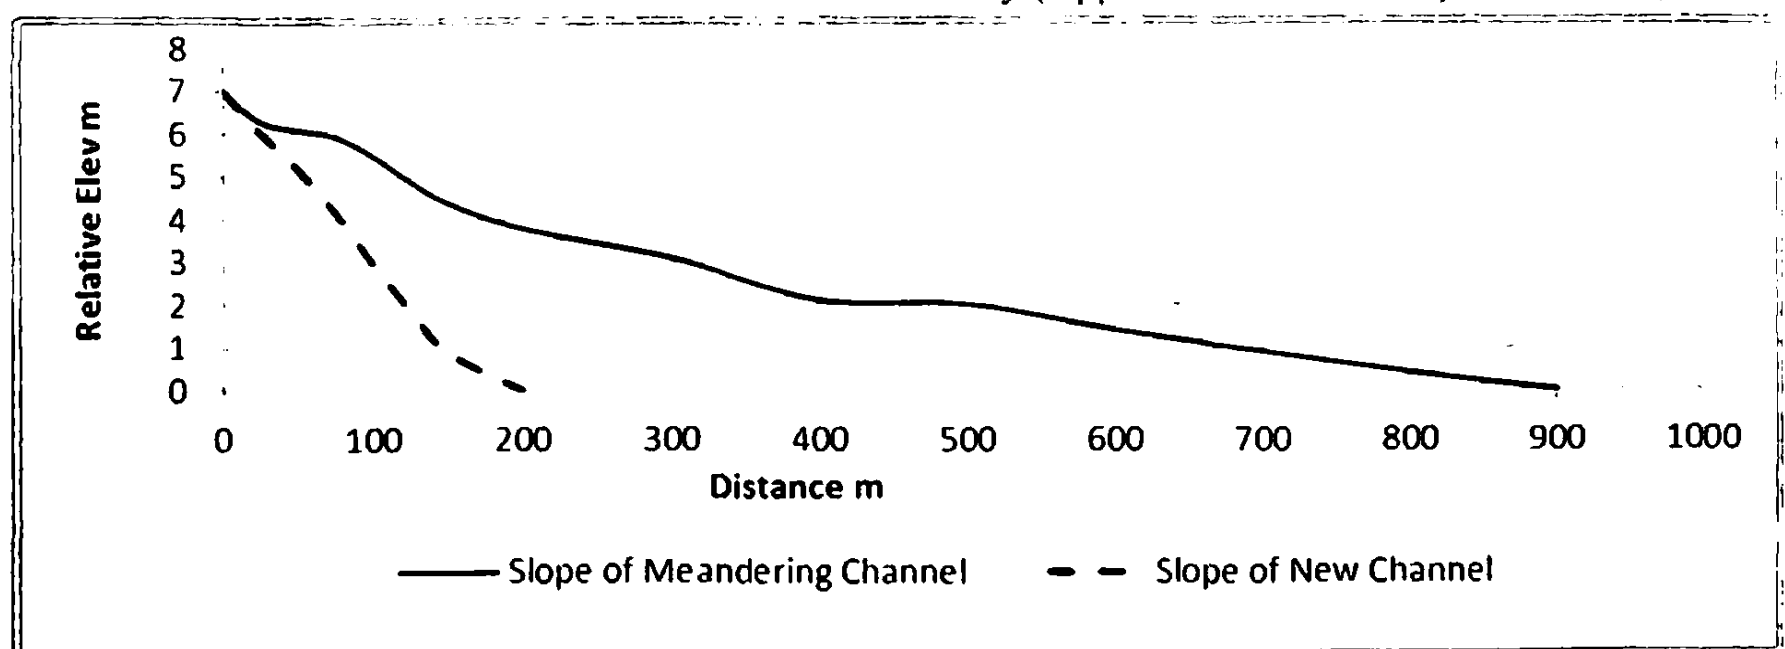
Fig. 9 Dik Oya channel slope before and after meander truncation.

The new channel has a steeper gradient compared to the former one (Figure 9). The elevation difference between the top and bottom of the new channel is about 7 m. Earlier the river flowed along a long meandering course with a gentler slope. Meander cutoff increased the gradient of

the channel leading to channel bed erosion as is clearly visible at the Malliyagoda Bridge (Figure 9). Bed erosion has extended up to the Wanasgalla Watta bridge at which concrete lined section of the river channel under the bridge prevents the erosional adjustment of the long profile further upstream. As a result, there is a bed level difference of about 1m at the downstream margin of the bridge and continues to erode.

After meander cutoff the channel length has shortened significantly causing an increase in the channel bed slope (Figure 9). The new channel expends its excess energy resulting from reduced resistance in the old long meandering course for

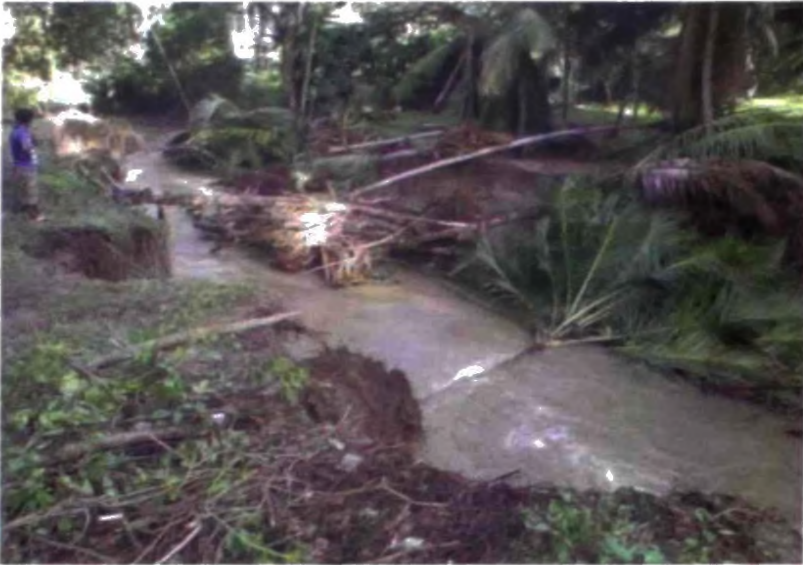
Plate 1 Newly built channel after meander cutoff.

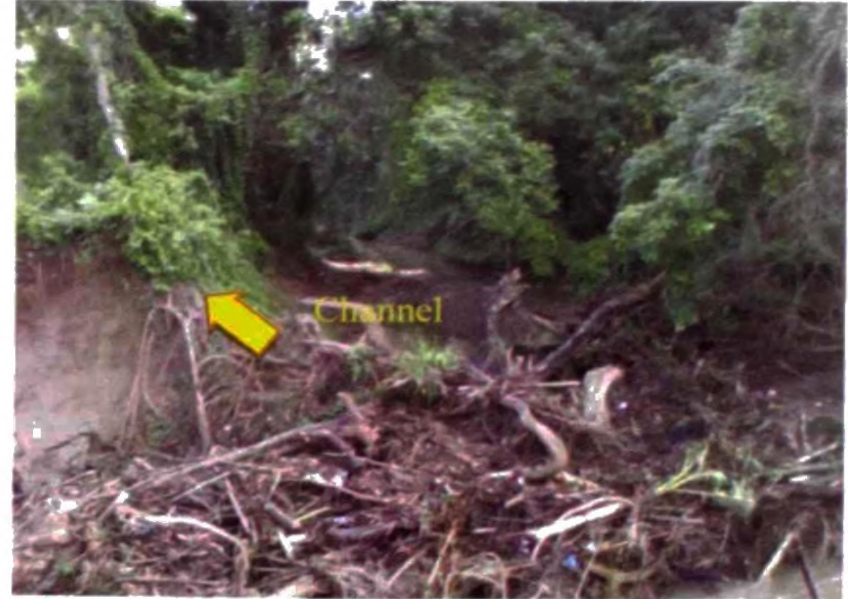
Plate 2 Abandoned channel with logs.

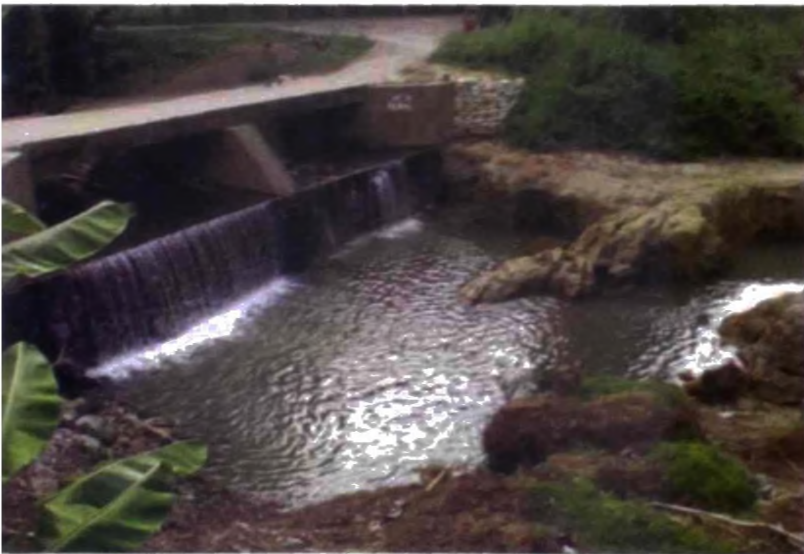
Plate 3 Bed erosion.

eroding the channel bed and banks as can be seen from Figure 10 and Appendix Plate 3. The upstream migration of channel bed erosion has been stopped by the concrete foundation of the Malliyagoda bridge.
