Preservation of Cultural Heritage in Earthquake-Prone Countries

Akira Wada^a, Hideki Kit Miyamoto^b, and Amir S. J. Gilani^c

Saint John Baptist Cathedral of Miragoane in Haiti

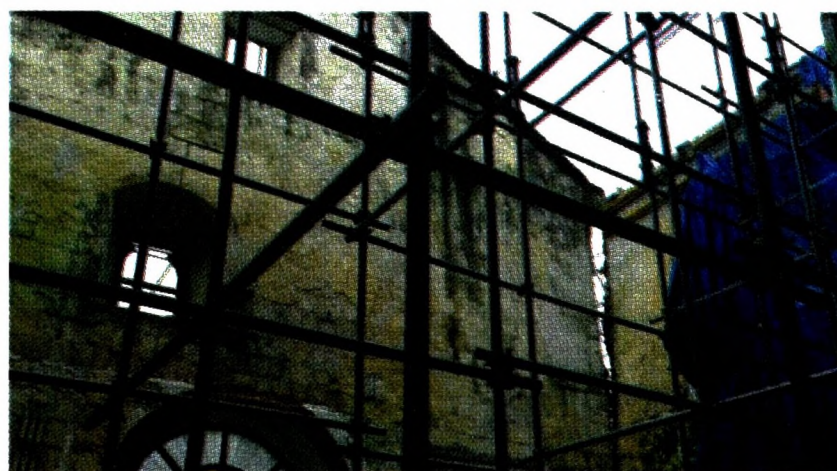
Damaged two Cathedrals attacked by strong earthquakes in Port-au-Prince, Haiti and in Bohol, Philippine, respectively

The main vertical and lateral load bearing members for these buildings are typically made of unreinforced masonry walls. These walls have experienced both in-plane and out-of-plane failures leading to the collapse of the structures. Given that the walls have little lateral capacity, it is critical to limit the input forces acting on them. In addition, these structures do not have a well-defined load path or diaphragm for the transfer of seismic loading.

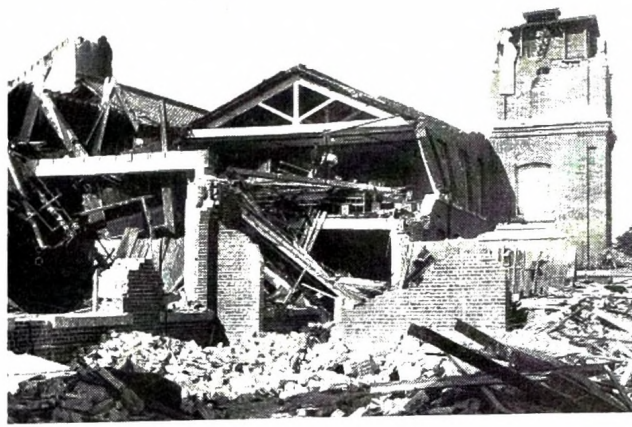
Damaged brick factory constructed by imported technology after Nobi Earthquake 1891

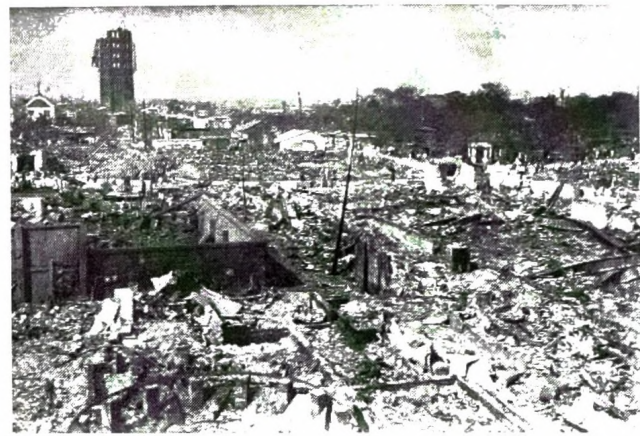
Collapsed 13 story masonry wall tower after Kanto Great Earthquake 1923

In the Kanto Great Earthquake in 1923, many buildings constructed of masonry wall systems collapsed. Dr. Toshikata Sano, Professor at the Imperial University of Tokyo, led a very important decision to prohibit the use of masonry structural systems in Japan from then on.

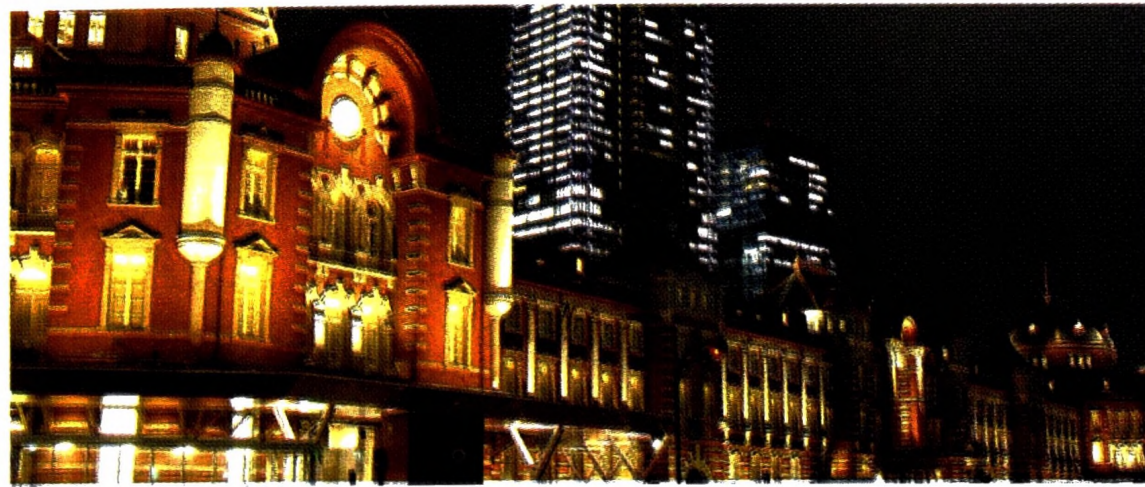
The Tokyo Station constructed in 1911 and completed retrofitting by seismic isolation on 2010.

thick walls and steel members for reinforcement and sustained only minor damage during the Kanto Great Earthquake. Examples of the above-mentioned buildings include the Prime Minister's House, the Main Office of the Bank of Japan, and the Tokyo Station. In the past 20 years, we installed seismic isolation devices beneath these buildings to provide earthquake protection.

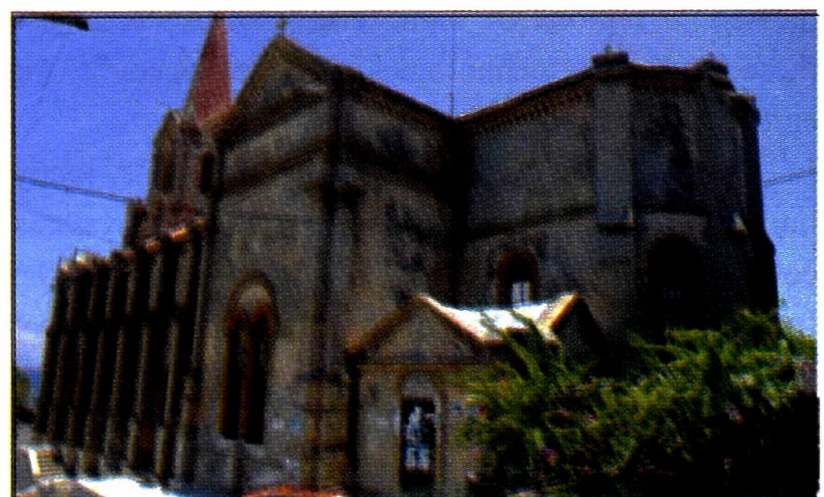
Photograph of the Cathedral Miragoane

The building has an area of approximately 580 m² and is nearly rectangular shape. The building is constructed using concrete floors with unreinforced masonry and stone (USRM) walls over stone masonry foundations. There is a ground floor and a mezzanine with access to the upper tower that houses the bell. The roof structure is assembled with trusses

that combine both wood and steel and is approximately 13.9 m tall at its peak. The roof is supported by the walls on the exterior and by uniformly placed columns along the interior.

The front entrance of the cathedral has a bell tower that stands approximately 30.5 m high. The tower is constructed with steel frames above the walls. There is a concrete mezzanine that sits about 7 m above the finished floor of the cathedral. The walls along the perimeter vary from 500 mm to 750 mm in thickness and are the primary gravity and lateral load resisting members. The Cathedral suffered minor damage, primarily minor cracking during the 2010 Haiti Earthquake. The damage to the building was minor because it was not located near the epicenter of the 2010 earthquake.
