# Vibration Analysis of Hydro Mechanical Structure Upper Kotmale Hydropower Plant

T. Namba

**Keywords:** Hydroelectric, Penstock, Vibration, Resonance, FEM

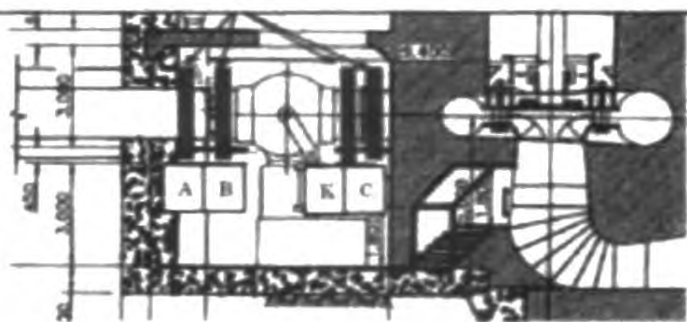
Figure 3 - Position Measured in the Tapping Test

Response spectrums and vibration mode shape obtained as a result of tapping test are attached in Fig.4. As a result of the tapping test, the following consequences are figured out.

- Penstock section has a natural frequency of 181.5Hz. That is close to the excitation frequency of 180Hz.
- Vibration mode of the penstock section at the frequency of 181.25Hz is 4ND shape.
- Vibration response level of penstock section is significantly higher compared to extension piece sections and spiral case sections.

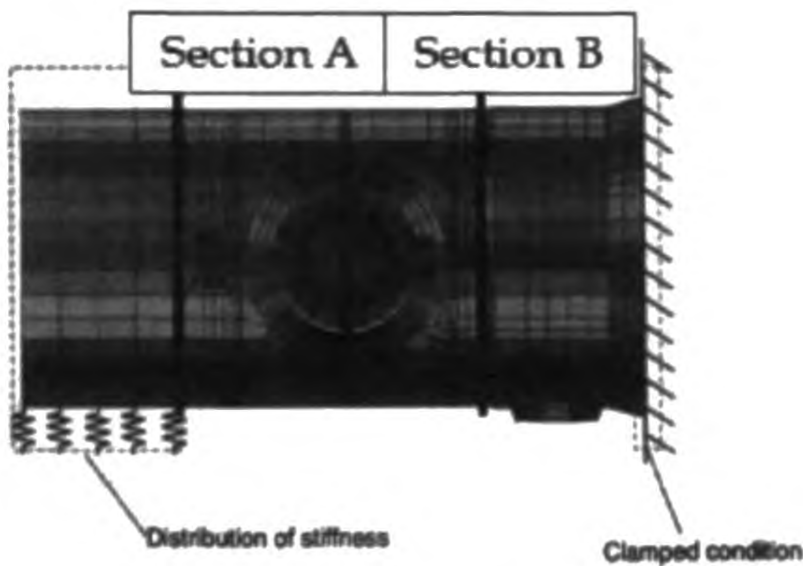
Figure 7 - Analysis Model

To reduce the vibration level, investigation was made to establish a countermeasure by using FEM. The investigation was aimed at establishing a countermeasure plan by providing a reinforcement around the penstock and avoiding the resonance against the excitation force of 180Hz. The calculation was made by modelling the penstock and upstream connection pipe. Calculation model is as shown in Fig.7. At the inlet valve side, fixed support was given as the boundary condition since the vibration in the inlet valve side is negligible according to the field measurement result, and the mass of the inlet valve is large. At the penstock side, stiffness was given at the concrete support position and the stiffness was adjusted by comparing with the field measurement result so that the most appropriate calculation result can be obtained. Fig.8 shows the comparison of the vibration mode shape between the field measurement and the calculation.

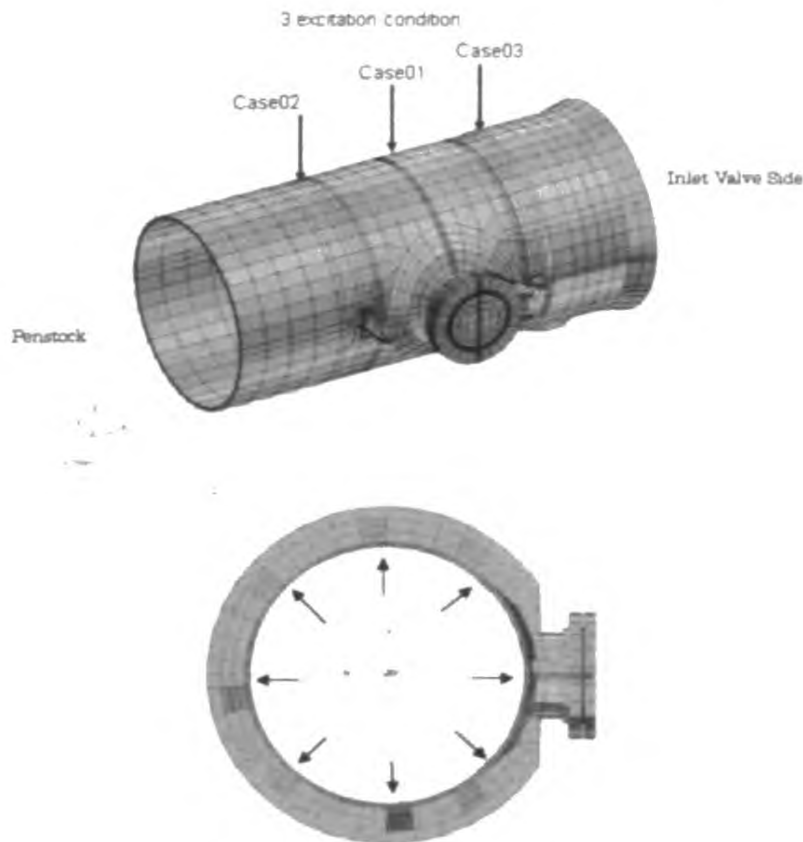
Figure 11 - Excitation condition used for the calculation

To grasp the response level of the vibration modes, excitation force was given at 3 different positions, and response analysis was done for each case as described in Fig.11. The calculation results are summarized in Fig.12.

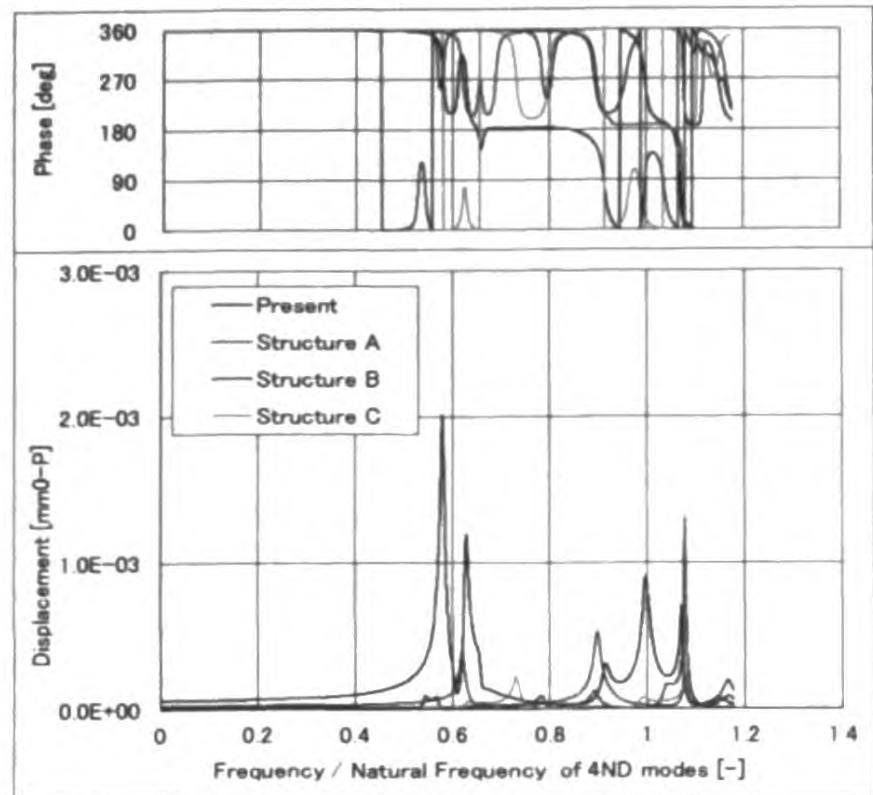
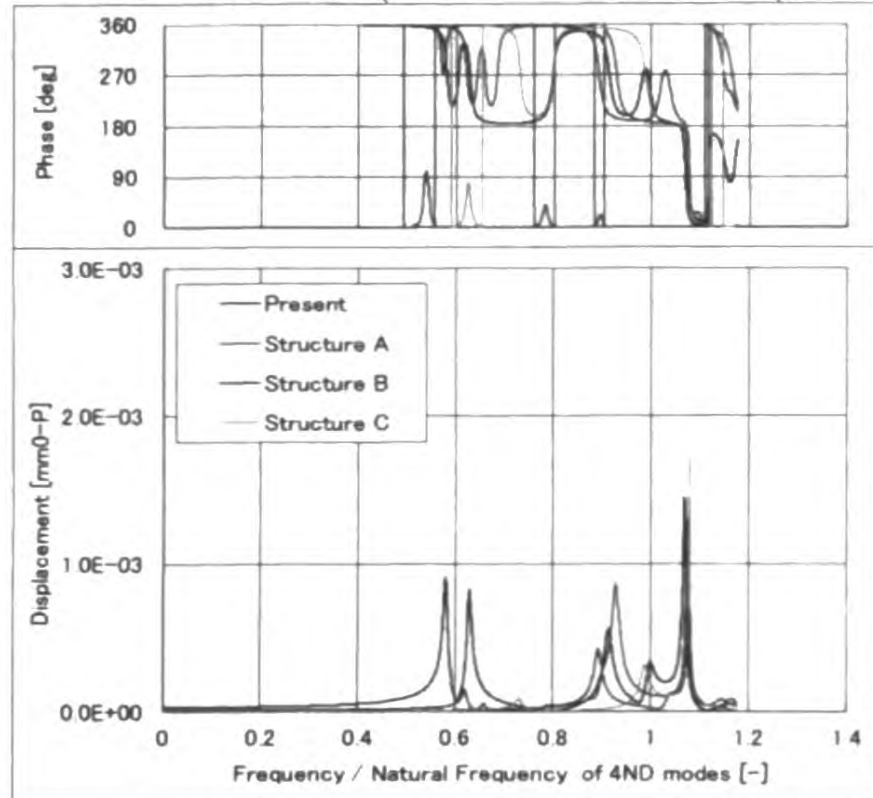
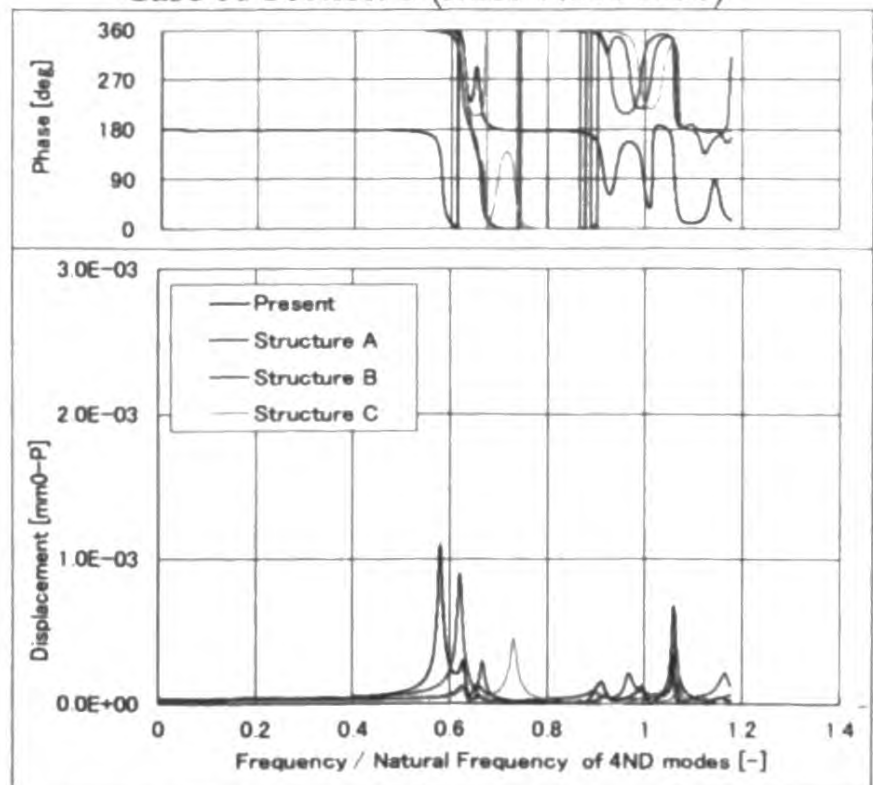
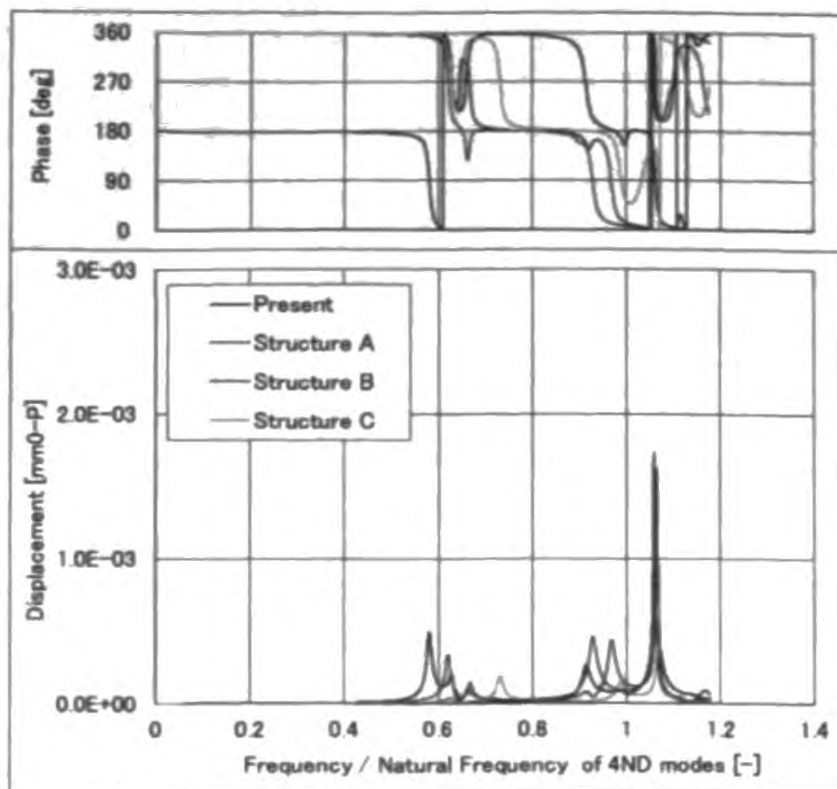
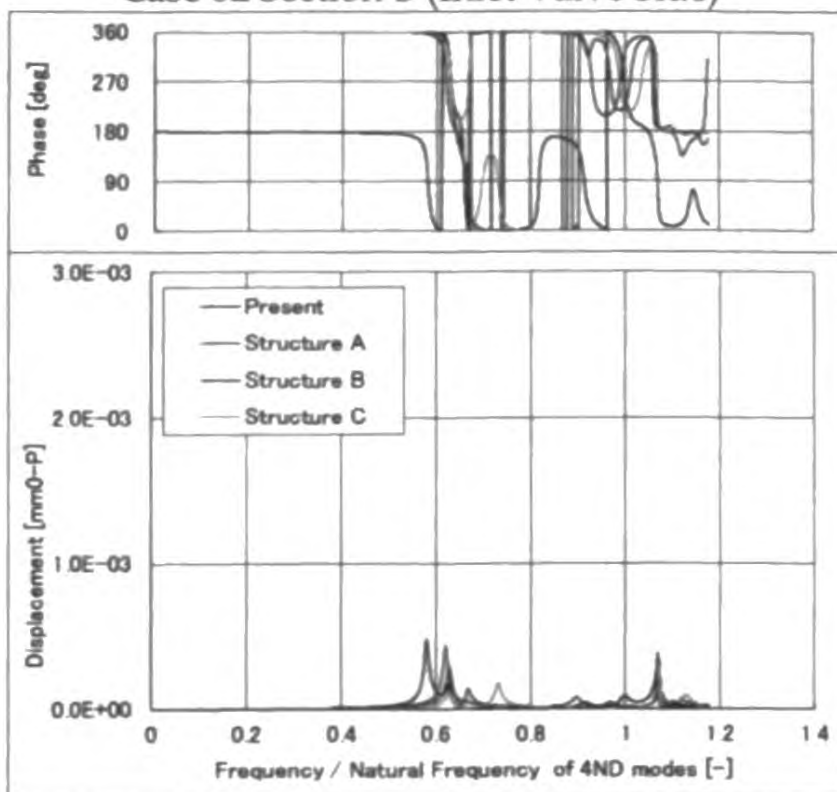
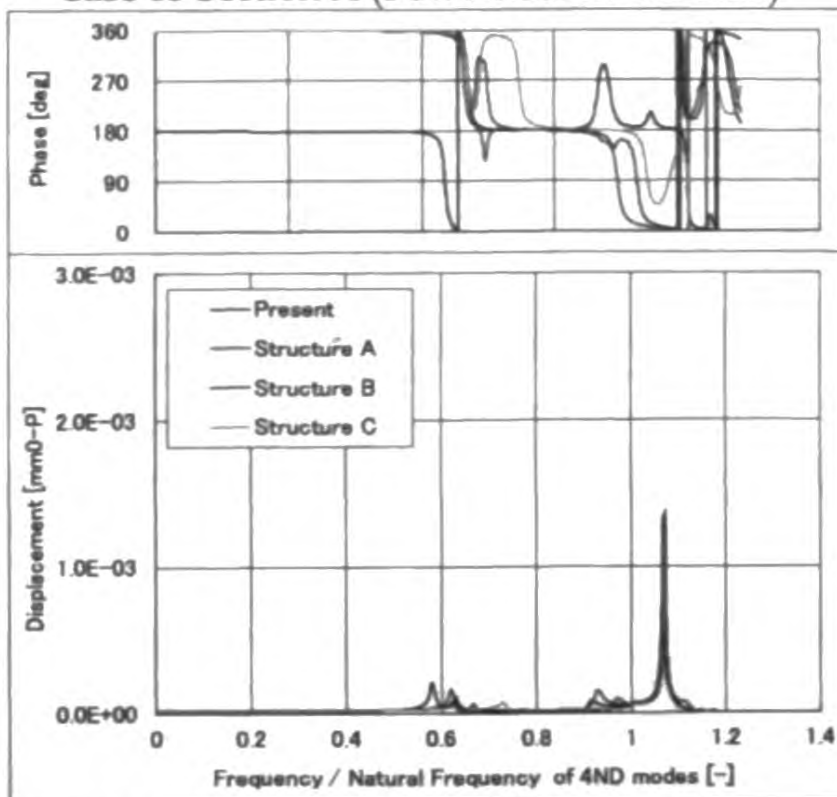
Figure 12 -Vibration Response Analysis Result

To reduce the vibration level in unit operation, natural frequency which has high response level shall not reside close to the excitation frequency. In Fig.12, abscissa axis is normalized by using the natural frequency of 4ND mode which is just on the excitation frequency of 180Hz. By providing stiffener, this 4ND mode can be increased to certain level and the resonance of this vibration mode can be avoided. But at the same time, other natural frequency that resides below 180Hz increases as the stiffness of the structure increases, and comes closer to 180Hz. In case 01 and 02 Section 2, the calculation result indicates the possibility that another natural frequency comes up closer to 180Hz and may result in resonance at 180Hz. Therefore we concluded that making the stiffness of the structure in excess is not favourable to give enough resonance avoidance ratios for all the natural frequencies against the excitation force frequency, and "Structure A" is the most appropriate way to reduce the vibration level as it does not have high response level natural frequency around 180Hz according to the calculation result. Countermeasure for vibration was taken up in March 2013 during the outage period based on "Structure A" of this calculation.
