Study on Risk of Accident by Heatstroke in Construction Industry of Japan

Abstract

This is the study on safety and quality improvement technique for construction and maintenance of building facilities. In this paper, the tendency of accidents in building facilities for the past ten years and the occurrence condition of fatalities disaster by heatstroke in construction in Japan is summarized. Finally the countermeasures and experiment for heatstroke are proposed

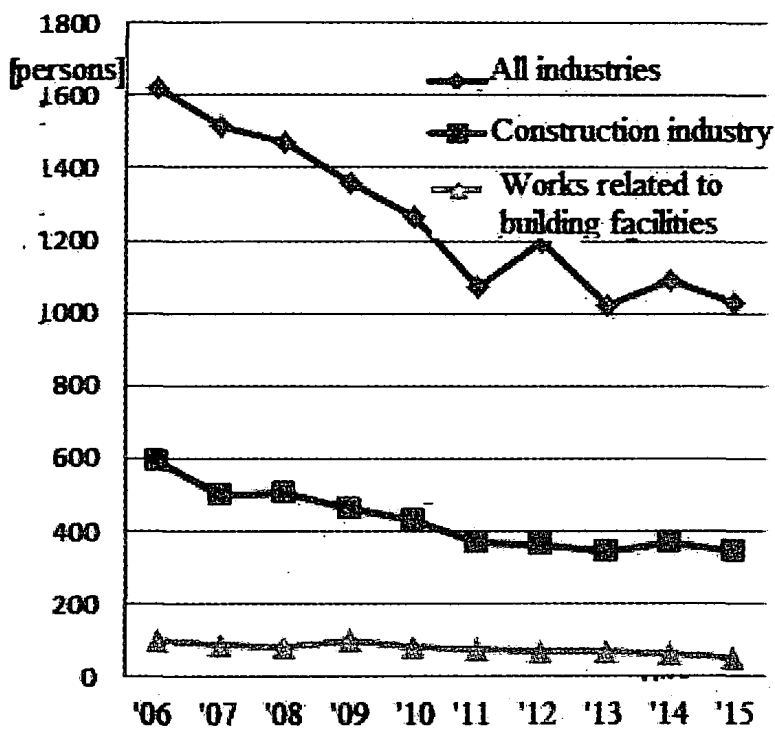
Fig. 1. Transitions of no. of fatalities, 2006 - 2015

Transitions in the number of fatalities in all industries, the construction industry and works related to building facilities for ten years from 2004 to 2013 is shown in Fig. 1 and the transitions in casualties in Fig. 2. Fig. 1 was constructed using

yearly data on statistics of occupational accidents "Fatal accidents according to the type of works/Conditions classified according to types of accidents in the construction industry" of The Japan Construction Occupational Safety and Health Association. In these data "Building Facilities" in the categories of Construction works and "Utility Construction Works (electro-communication, machinery and others)" are distinguished as two different types of works, but they were added in the present study as they represent works related to building facilities.

According to the data, the number of fatalities in all industries declined gradually from 1,600s in 2004 to 1,000s in 2013. A sharp fall was observed in 2009 and 2011, which can be attributed to economic slowdown in the construction industry as a result of the Lehman Shock in September 2008 and the Great East Japan Earthquake in March 2011.

The number of fatalities in the construction industry accounts for about 34% of the total number of fatalities in all industries, out of which nearly 20% is represented by works related to building facilities. Fatalities in works related to building facilities comprise nearly 7% of total fatalities in all industries.

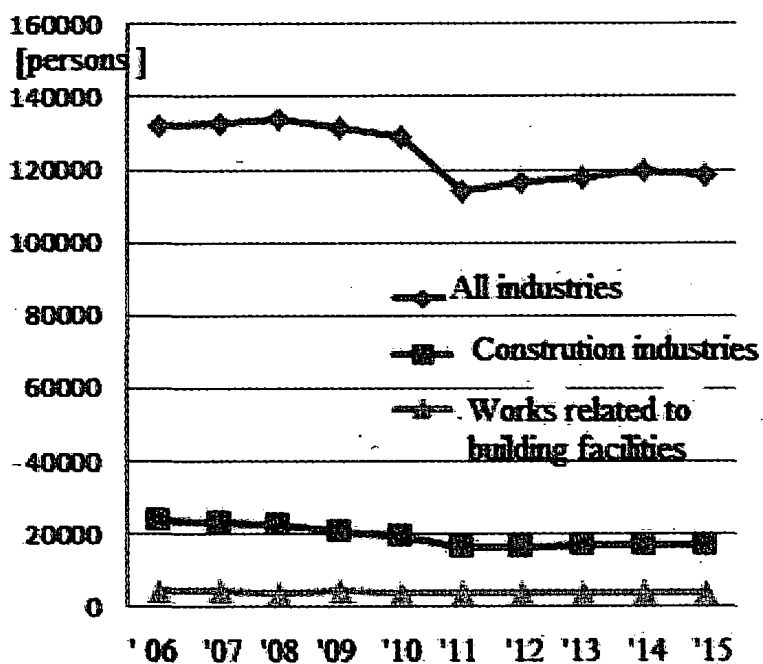
Fig. 2. Transitions of no. of casualties, 2006 - 2015

Fig. 2 was constructed using yearly data from the statistics of occupational accidents "Occurrences of life-threatening disasters according to types of industries and accidents (fatal accidents and four days-off or longer) of the Japan Advanced Information Center of Safety and Health in the Japan Industrial Safety and Health Association. In the data "Works on Building Facilities" under the category of Construction Works and "other construction work (electro-communication, machinery and equipment installation, and other construction works)" are distinguished as two different types of works, but they were added in this study as they represent works related to building facilities.

As for number of casualties, that of the construction industry accounts for about 16% of the total number in all industries, out of which nearly 19% is represented by works related to building facilities. Casualties in works related to building facilities comprise nearly 3% of the total casualties in all industries. The proportion of casualties in the construction industry to those in all industries is about 16% whereas the proportion of fatalities in the construction industry to those in all industry is 34%, suggesting that accidents in the construction industry are more likely to lead to fatal disasters.

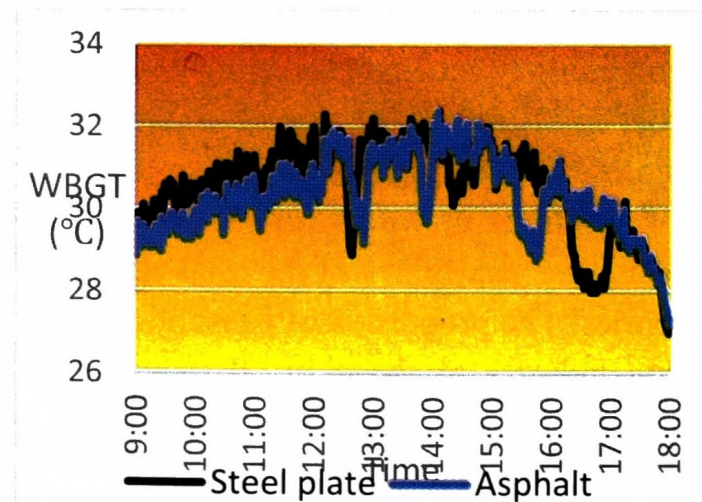
Fig. 7. Temporal change in the WBGT (July 22)

No big differences were observed in WBGT. But as Fig. 7 and the Table illustrates, the index mostly stayed above the stern warning level. But the WBGT abruptly decreased. This may be because humidity changed substantially and lowered the WBGT.
